AMMRC TR 84-39

# MOBILE ACCELERATOR NEUTRON RADIOGRAPHY SYSTEM

W. E. DANCE, S. F. CAROLLO, AND H. M. BUMGARDNER  
LTV AEROSPACE AND DEFENSE COMPANY  
VOUGHT MISSILES AND ADVANCED PROGRAMS DIVISION  
P. O. BOX 650003  
DALLAS, TEXAS 75265-0003

FINAL REPORT

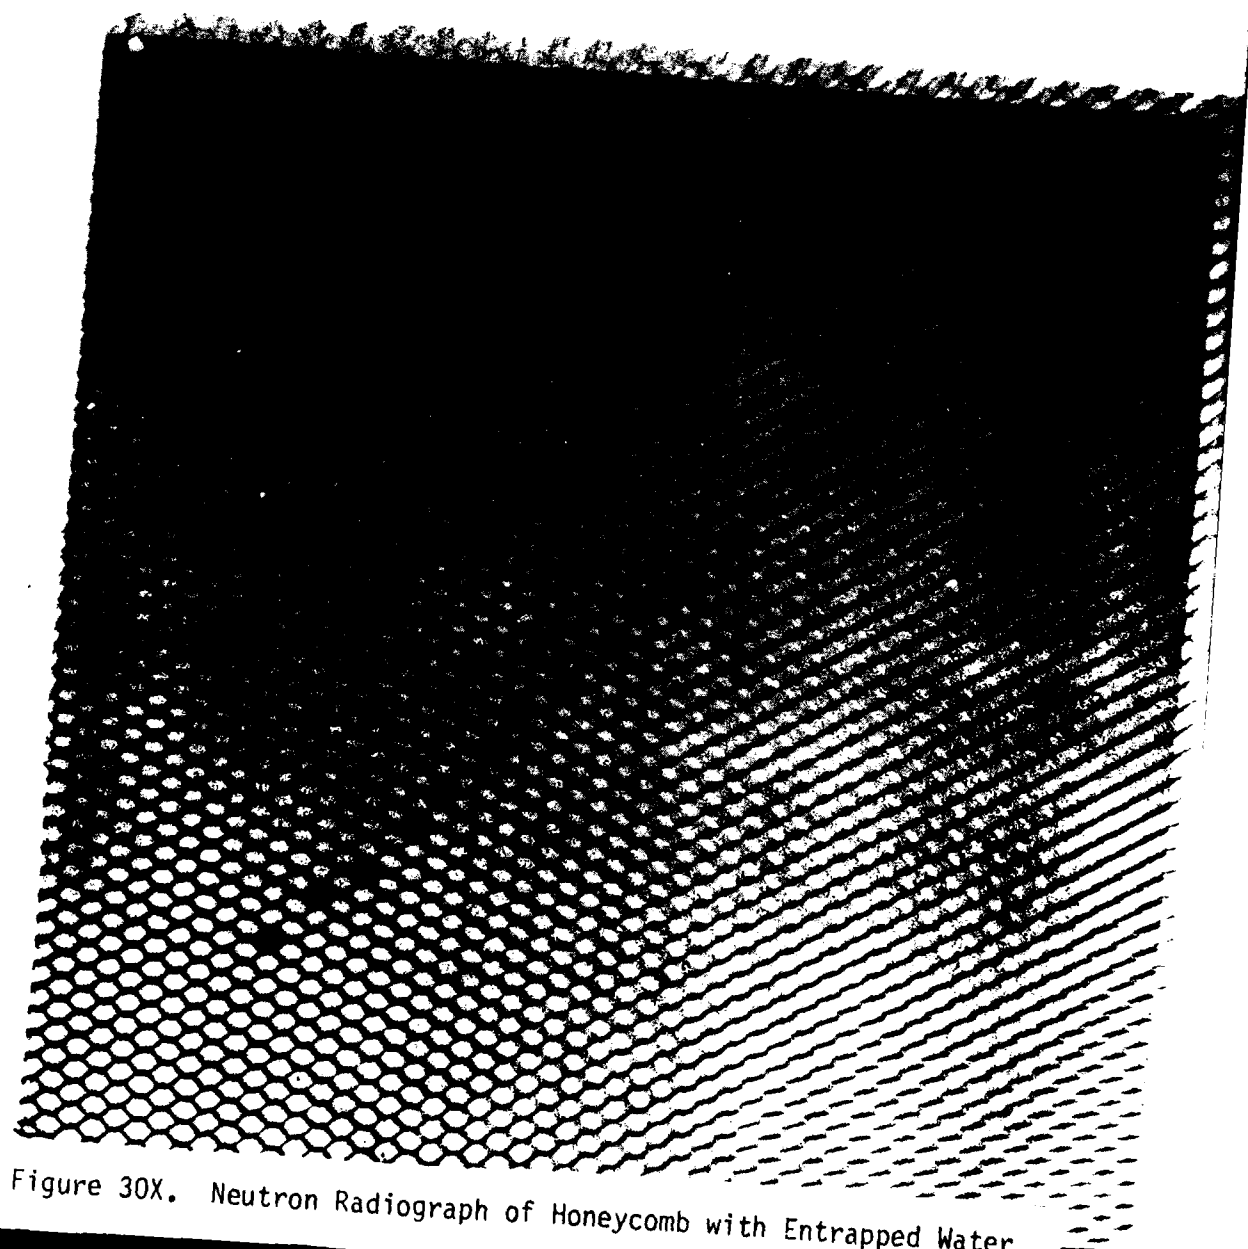
The next pair of radiographs (Figures 30N and 30X) is a comparison of n- and x-ray for imaging water in honeycomb structures. The series of spots are images of water droplets confined to single core cells, in various amounts, and at various depths in the honeycomb. In the upper right portion, it is seen that the quantity of water decreases as the filled cells progress toward the upper right hand corner. It is seen also that the neutron radiograph has greater contrast sensitivity for imaging water droplets than the X-ray. Also, from the neutron radiograph the relative depth of the water drops in the panel

Figure 30X. Neutron Radiograph of Honeycomb with Entrapped Water

is indicated, since the image sharpness decreases as the object-to-film distance increases, due to the low L/D ( $\sim 12$ ) of this exposure. For example, beginning at lower left, the fifth droplet is sharpest and hence is the closest one to the film side of the specimen; the third one is next in closeness; nos. 6 through 11 all appear to be at the same depth; and nos. 2 and 12 through 16 all appear at approximately the same depth, farthest from the specimen's film side of the specimen. The x-ray image cannot be used in a similar manner to ascertain depth since all the spots appear with rather uniform sharpness, due to the "point source" nature of x-ray exposure geometry. The neutron radiograph also indicates that the adhesive layer is highly non-uniform in thickness, which is a condition not readily detected in the X-ray.

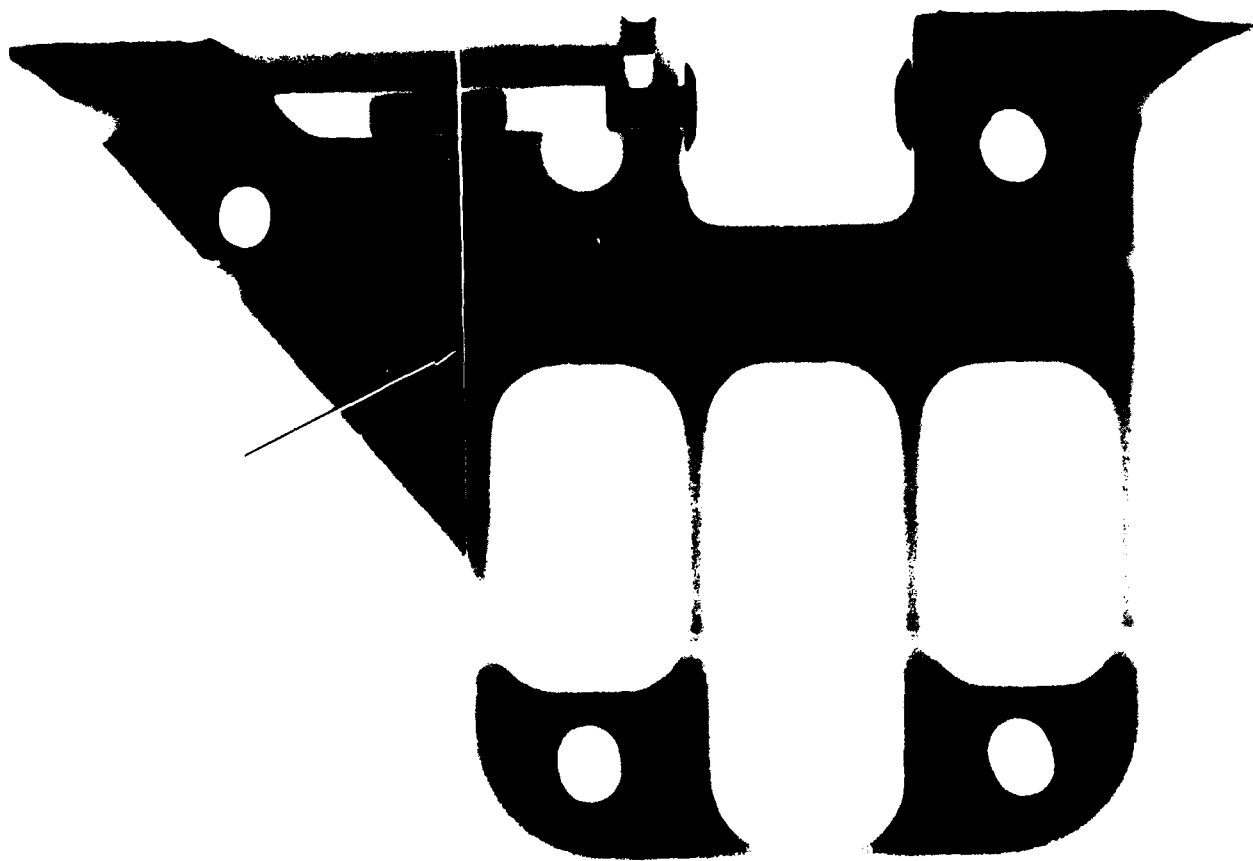
A series of radiographs was made to evaluate application of this type mobile system to inspection of large structures such as the space shuttle thermal radiator panels manufactured by Vought. Figures 33X and 33N are x and neutron radiographs of one of these panels in the area of an aluminum fixture bonded into the panel. In this case, the specific area in question was the edge bond between two components comprising the fixture. As seen, the x-ray does not image this bondline, and the neutron radiograph images all the bonding material in the structure, indicating an inadequate bond in the area denoted. Figure 34N is a neutron exposure made at an oblique angle of approximately 40 degrees from perpendicular to the beam, in order to determine the depth of the questionable edge bond. As seen, the depth profile of this bondline is faithfully imaged. Based on these images, a repair of this area by simple adhesive injection at the appropriate points was effected, which obviated the need for skin removal.

Figure 33X. X-Ray Radiograph of Space Shuttle Thermal Radiator Panel Assembly
